CASE STUDY:
**MATRA
 POWER
 STATION**
 HUNGARY

MODIFICATIONS TO THE AIR PREHEATERS INCREASED THE BOILER EFFICIENCY BY OVER 1.9%

DETERIORATION OF THE SEALING SYSTEM ON THE AIR PREHEATERS HAD RESULTED IN VERY HIGH LEVELS OF AIR LEAKAGE INTO THE FLUE GAS. MODIFYING THE EXISTING SEALING SYSTEM TO THE HOWDEN VN CONCEPT HAS REDUCED LEAKAGE FROM 24% TO 4.7% WITH A CONSEQUENT IMPROVEMENT IN BOILER EFFICIENCY OF 1.9%. THIS HAS PERMITTED THE STATION TO REDUCE FUEL CONSUMPTION AND TO REDUCE THE LOAD ON THE ID FANS.

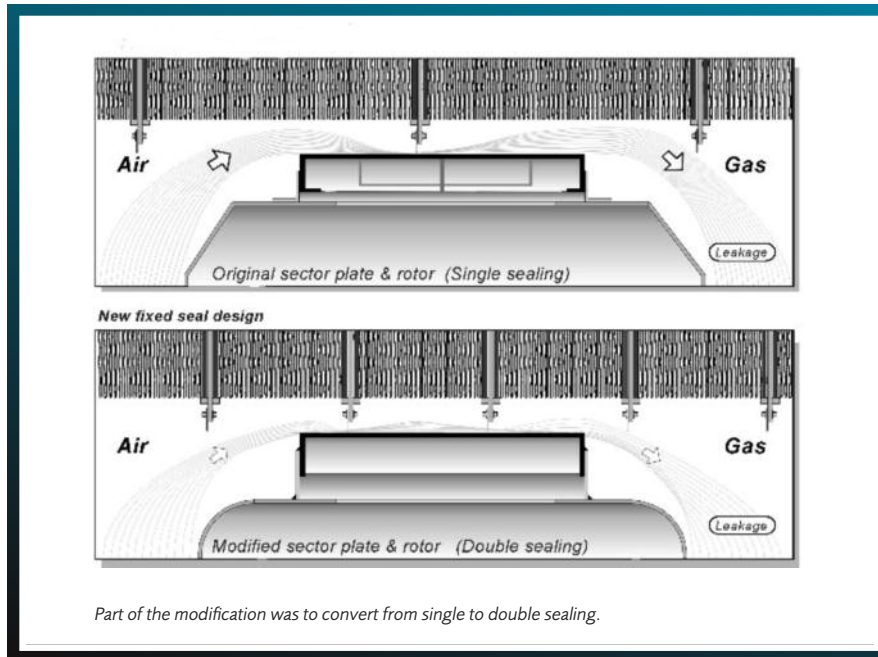
At the same time, new element baskets were fitted and bypass seals were replaced, which reduced the bypassing of air and gas through the rotor, in order to improve heat recovery. The station came back into service in September that year. The upgraded air preheater sealing considerably reduced the mass flow of gas flowing to the chimney, which, combined with the improved heat exchange, resulted in a significant reduction in the dry stack loss with consequent improvement in boiler efficiency.

Tests carried out by the power station before and after the modification showed that the air leakage reduced from 24% to 4.7% and the mass flow of flue gas dropped by a corresponding amount. Flue gas leaving the air preheater fell in temperature from 205°C to 164°C (undiluted), and the boiler efficiency increased by 1.9%. An additional benefit was that the considerable reduction in flow through the FD and ID fans resulted in a significant saving in auxiliary power. The elimination of moving sector plates means that annual maintenance hours are reduced.
